# Electrical safety Audit Report

For  
**MAHATMA EDUCATION SOCIETY  
RASAYANI - HOC**

Presented By  
**NEW RB ENERGY CONSULTANCY**

Conducted on – 16 MAY-2024

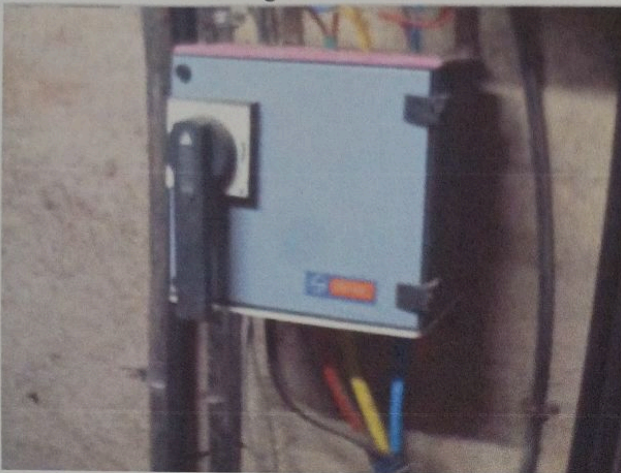
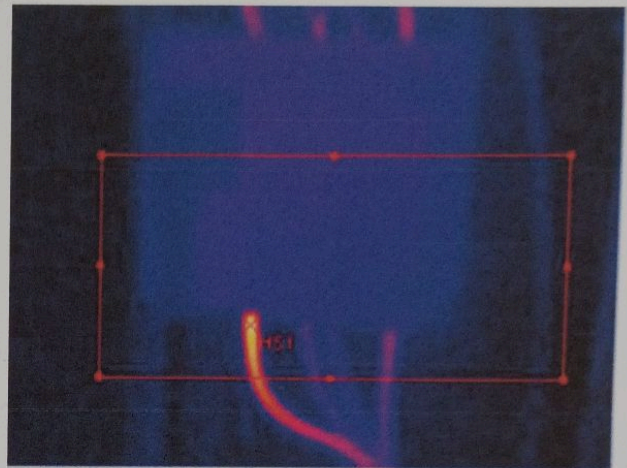
Image No: - 01

Location	Main Panel room
Equipment	Changeover
Fault Location	N - Phase
Area Temperature	26.4

Object Parameters	Value
Image File Name	00078
Emissivity	1
Max Hot Spot Temperature	71.6
Fault Rating	Priority 1

Found hit on N – Phase due to loose connection.

Corrective action should be taken at the next planned maintenance activity

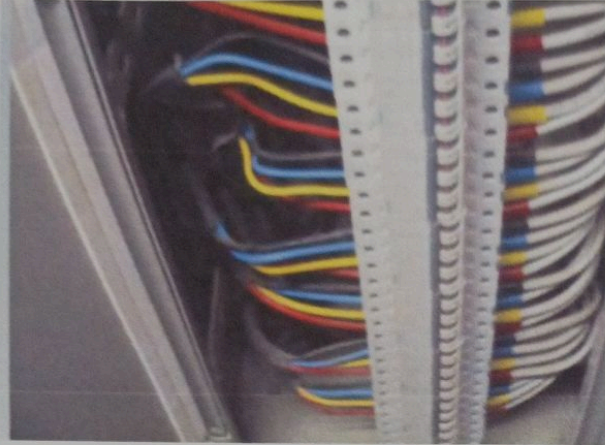
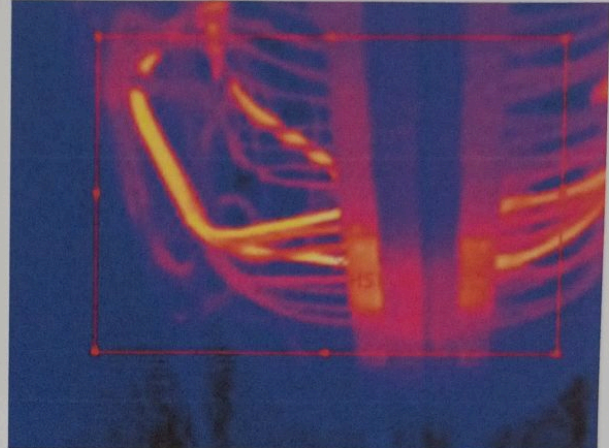
Image No: - 02

Location	Main Electric room
Equipment	Connector
Fault Location	N - phase
Area Temperature	26.4

Object Parameters	Value
Image File Name	00077
Emissivity	1
Max Hot Spot Temperature	59.7
Fault Rating	Priority 2

Found hit on N - phase terminal due to loose connection.

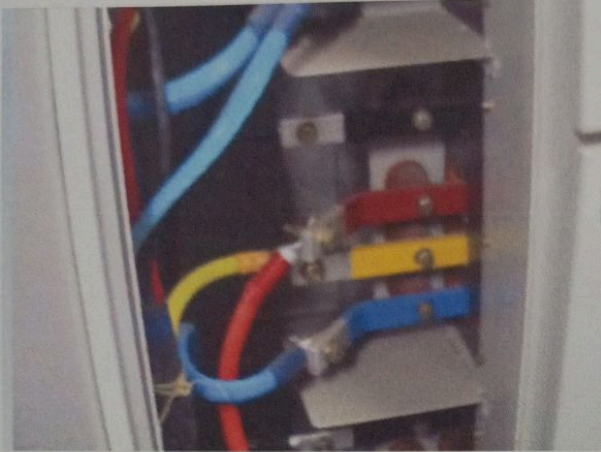
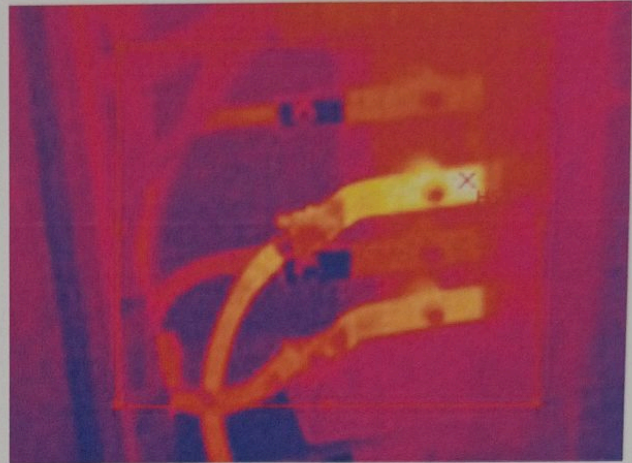
Image No: - 03

Location	Main panel room
Equipment	MMS Hall, 400amp.
Fault Location	R - Phase
Area Temperature	26.4

Object Parameters	Value
Image File Name	00076
Emissivity	1
Max Hot Spot Temperature	43.6
Fault Rating	Normal

Found Normal

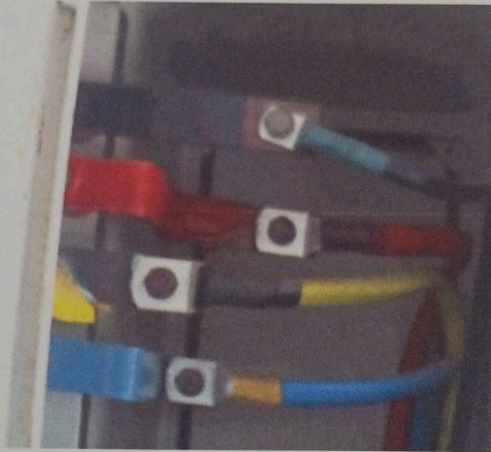
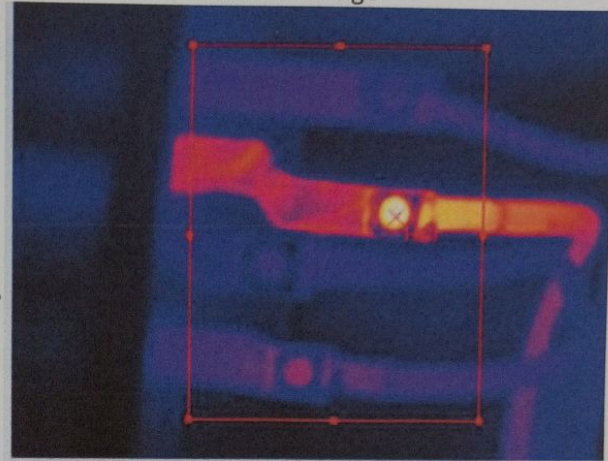
Image No: - 04

Location	Main Electric room
Equipment	Engg. Main 400amp.
Fault Location	R- phase
Area Temperature	26.4

Object Parameters	Value
Image File Name	00071
Emissivity	1
Max Hot Spot Temperature	86 C*
Fault Rating	Priority 1

Found loose connection on R-phase

Corrective action should be taken at the next planned maintenance activity

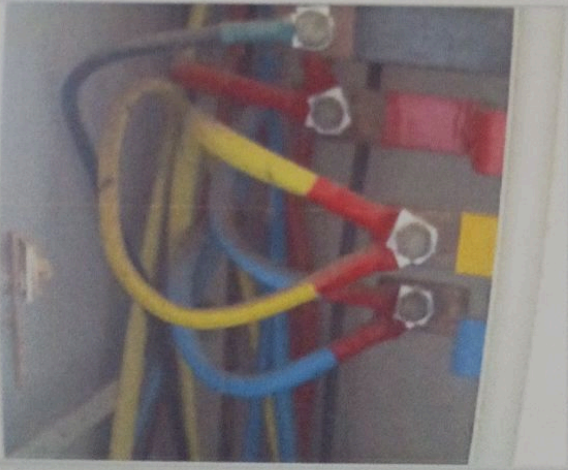
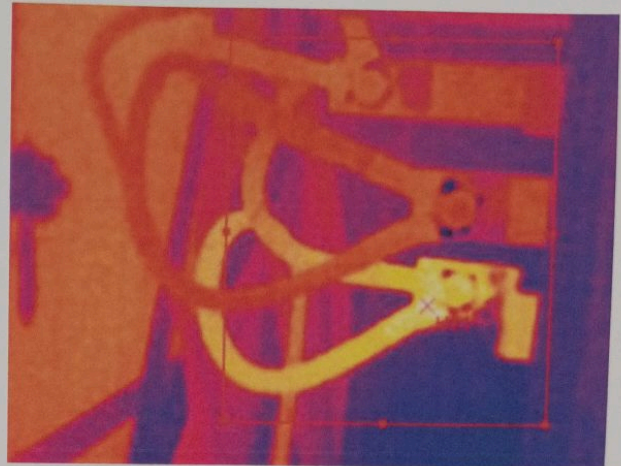
Image No: - 05

Location	Main Panel room
Equipment	Com-5, 400amp.
Fault Location	B - phase
Area Temperature	26.4

Object Parameters	Value
Image File Name	00069
Emissivity	1
Max Hot Spot Temperature	38.5
Fault Rating	Normal

Found Normal

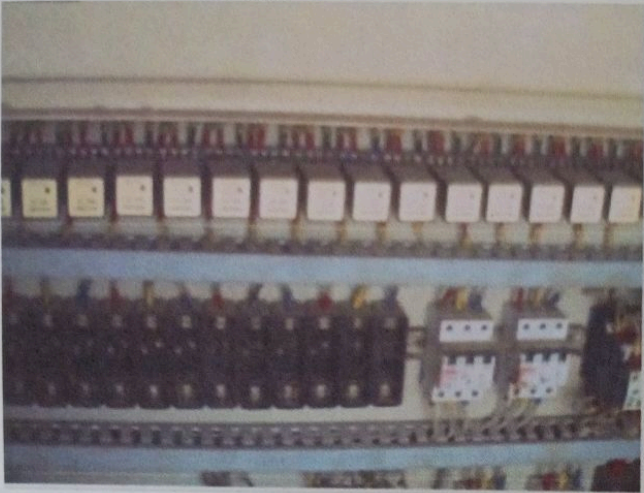
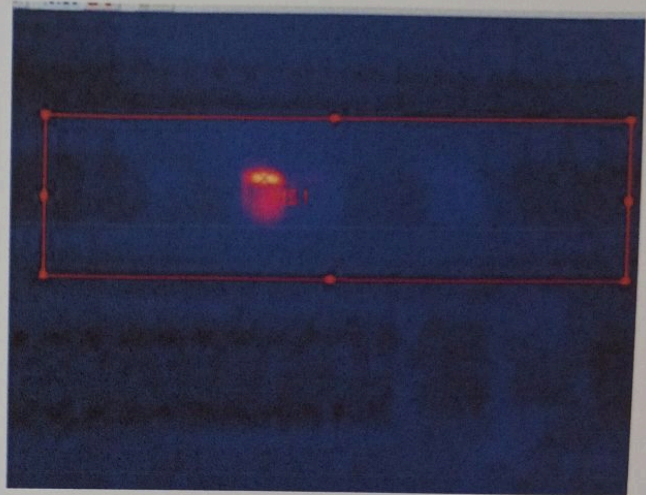
Image No: - 06

Location	Main panel room
Equipment	Capacitor panel
Fault Location	Fuse
Area Temperature	26.4

Object Parameters	Value
Image File Name	00068
Emissivity	1
Max Hot Spot Temperature	26.5
Fault Rating	Normal

Found ok  
Its Normal
